INSTALLATION RESTORATION PROGRAM

Final DECISION DOCUMENT UST SITE 175

117th Refueling Wing Alabama Air National Guard Birmingham Airport Birmingham, Alabama

January 1997

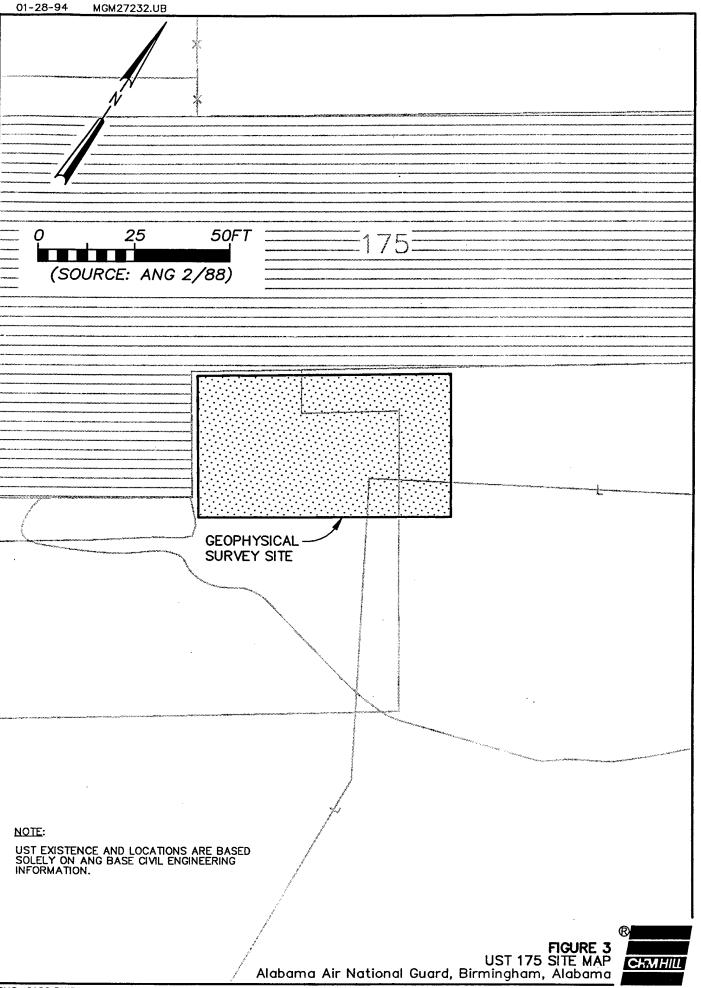
UST 175's contents were unknown based on information found during the initial investigation of the AANG facility. Figure 3 shows the suspected location of UST 175.

During the Tank Survey Task to identify the location and sizes of the tank, magnetic devices and Ground Penetrating Radar (GPR) were used to identify tank boundaries and sizes. The information from the GPR survey did not indicate anomalies that represent an underground structure at the UST 175 site.

Further review of aerial photography and base records contained minimal information on UST 175. UST 175 was not found and no further action was taken.

Because no UST was found, it is recommended that this site be removed from further IRP activities and that no further action be required.
